Crack monitoring survey during rough water trials period #2

02/08/2011 – 02/14/2011

The Performance and Evaluation Branch (Code 6S3) of the
Structures and Composite Division (Code 65), Naval Surface Warfare Center – Carderock

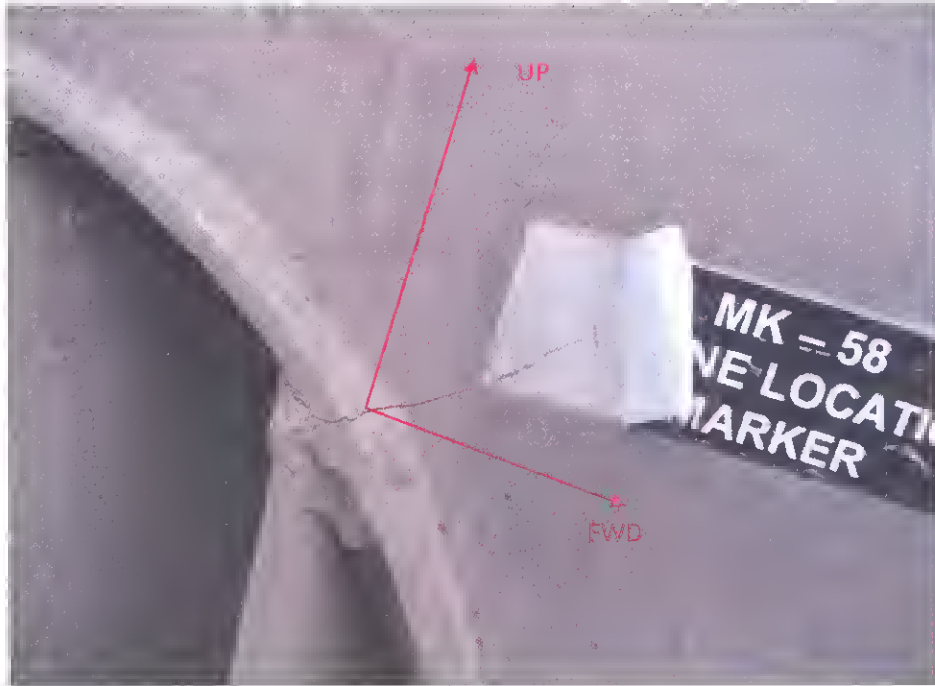
2. This crack is in the top forward corner of the intake. The crack extends from the shell plating and into the collar forming the rim of the intake. Of the 6.375" total length only 3.375" is in the shell plating while the rest is in the collar itself.

Figure 2: Frame 25, 01 Level, Intake 5-18-01-E top forward corner

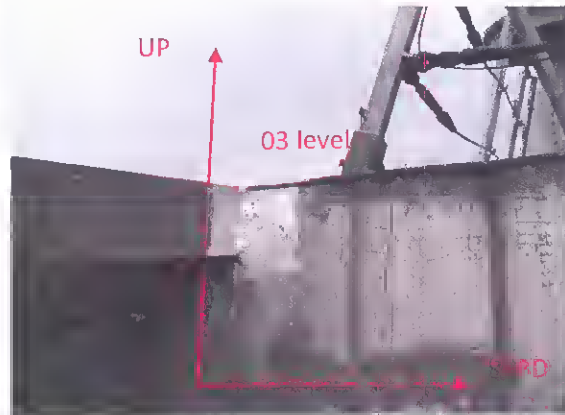
6. The re-cracking at this location was first discovered on 02/10/2011. When discovered the crack ran a total of 8.875". This weld is where the top of the shell facade that covers the rocket launch area and life boats mates to the aft exterior face of CE5R #2. The crack ran 1.375" on the outboard side rounded the corner and covered the entire 5.5" upper width of the facade and then turned the corner and ran 2" down the interior of the shell. The upper portion of the facade is an upside down "U" channel. The crack runs along all three surfaces of the "U". On 02/11/2011 a 0.25" crack growth was found on the outboard portion on the crack. No crack growth was discovered until 02/13/2011. That time a growth of 0.875" was discovered on the outboard side again as well as a growth of 0.125" on the inboard side. On 02/14/2011 crack growth was again found in the outboard crack. The outboard crack now measures 3.125" and travels the complete length of the repair weld shown in Figure 9. These last two crack growths contributed to the overall length of 10.75".

Figure 7: Top Right, Frame 41, 03 Level, Deck edge, Port, Inboard

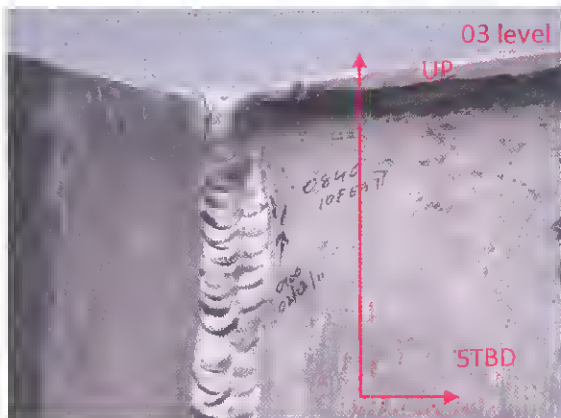
Figure 8: Bottom Left, Frame 41, 03 Level, Deck edge, Port, Inboard crack

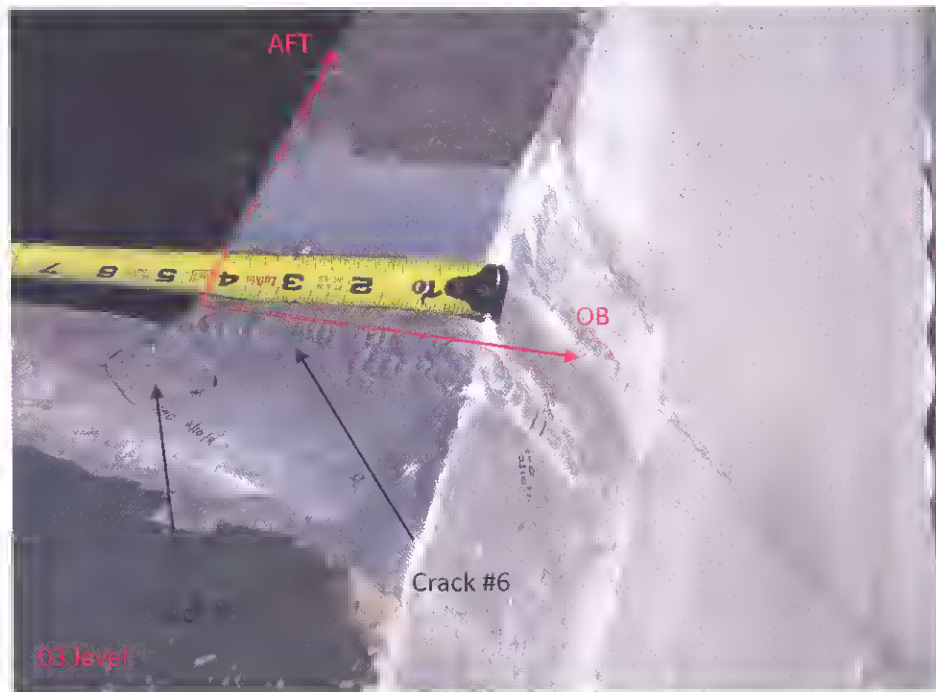
7. The location of this crack is very close to crack #6. It is actually in the deck plating of the 03 level just forward of crack #6. It is in a slight crescent shape and was discovered on 02/10/2011 and has not grown since then. This crack measured 1.75" from tip to tip but is actually slightly longer due to the shape of the crack.

Figure 10: Frame 41, 03 Level, Deck edge, Port, Crack #8

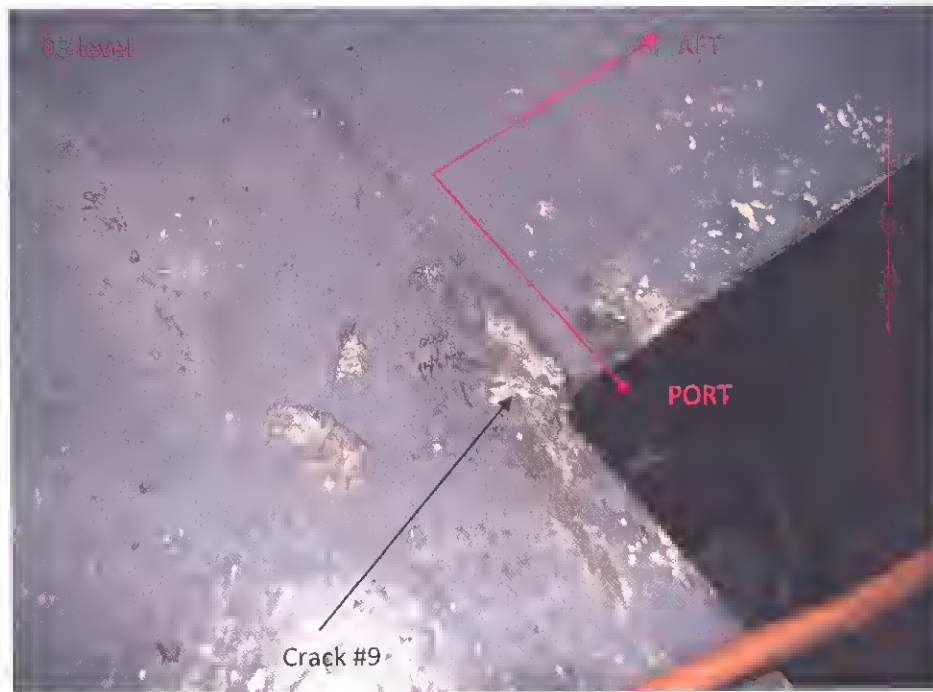
9. The inspectors were not made aware of this crack until 02/13/2011 When found it measured 1.125" long. It extends from corner of a walkway on the 03 level.

Figure 12: Frame 41, 03 Level, Port side of center walkway

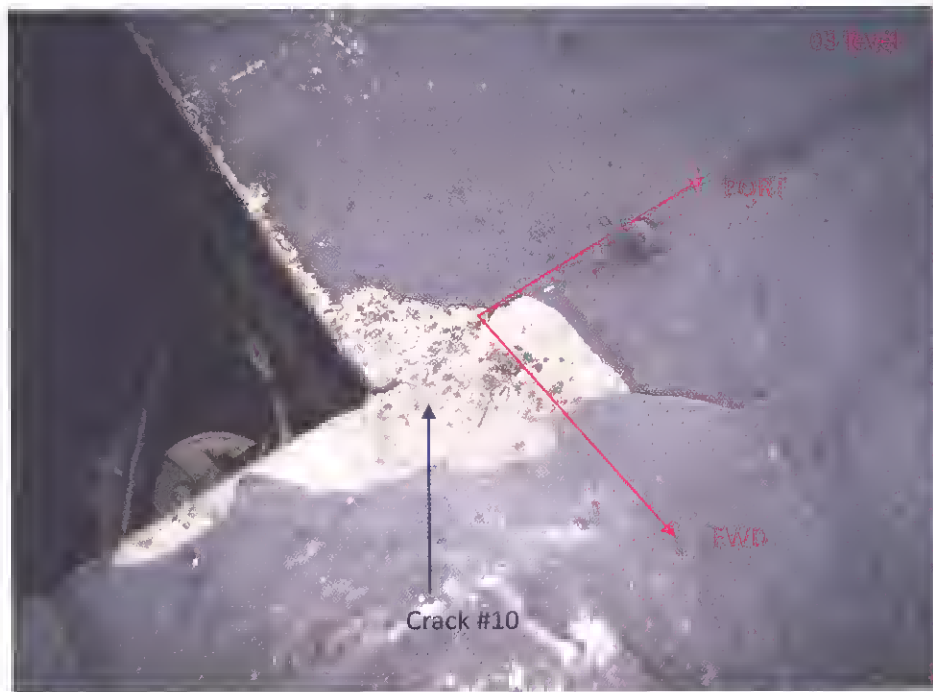
10. This crack matches crack #9 only on the starboard side. It measured 2.25" upon discovery on 02/13/2011.

Figure 13: Frame 41, 03 Level, Starboard side of center walkway

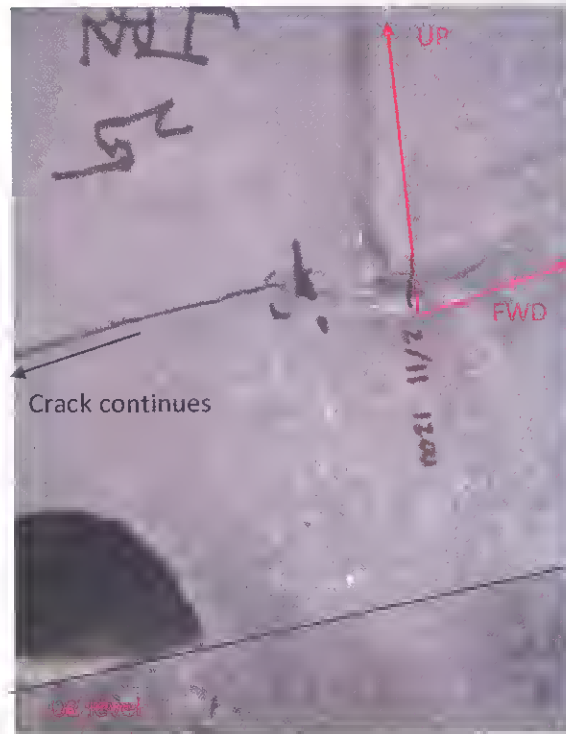
11. This crack is in the weld that mates the starboard side shell facade covering the rocket launch area to the 02 level deck plating. It was shown to us by the crew on 02/11/2011 and has not grown past the 11.125" it was when discovered.

Figure 14: Frame 41.5, 02 Level, Starboard, Outboard view of shell plating

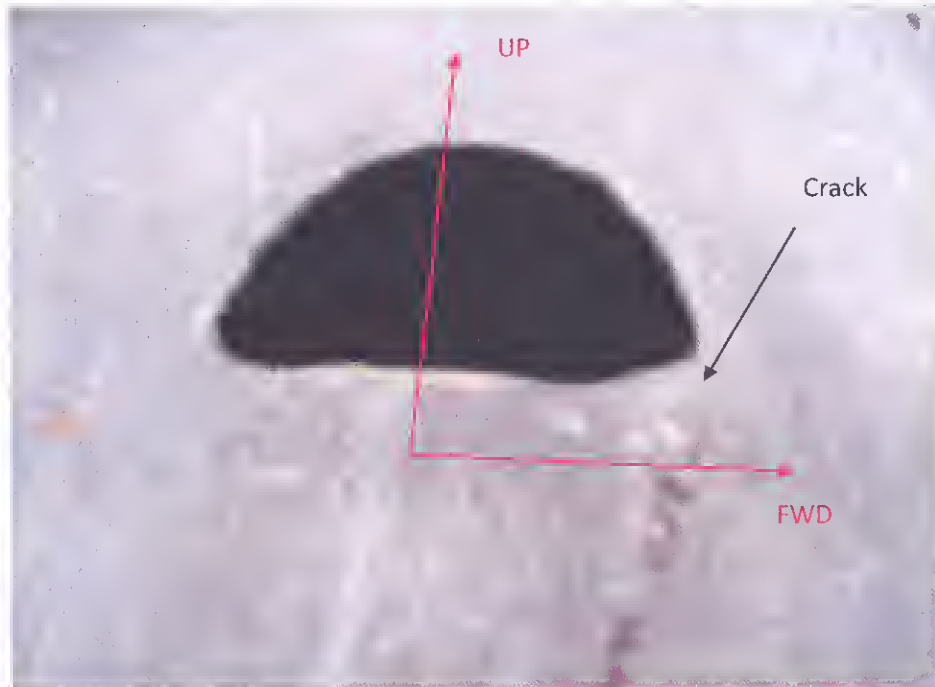
12. This crack was discovered the same day as crack #11. It was found when inspecting crack #11 as is in the corner of a drain hole off the 02 level.

Figure 15: Frame 41.5, 02 Level, Starboard, Outboard view of shell plating, Deck drain

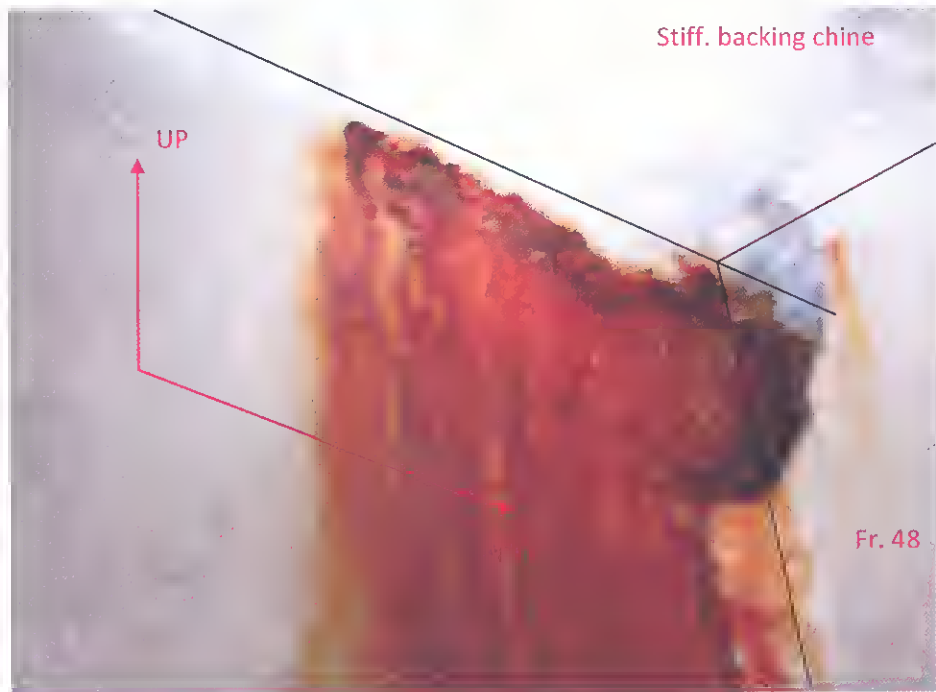
13. This crack was discovered by a crew member. It is below the waterline and is currently allowing water in. It is located where the chine meets the lower portion of hull. It travels through a cut out in frame 48 and totals 4" in length. When discovered there was rust washing onto the painted surface. It is thought this is rust from the exposed crack surface. It is unknown how long this crack existed prior to being discovered.

Figure 16: Frame 48, 2nd Platform, Starboard, View looking at frame 48 and chine stiffener

Due to the crack below the water line rough water trials has been suspended. These cracks will be monitored by code 65 until the ship arrives in port at San Diego, CA. Any changes to the cracks will be reported to CO Edwards and John Fulton as has been done previously.

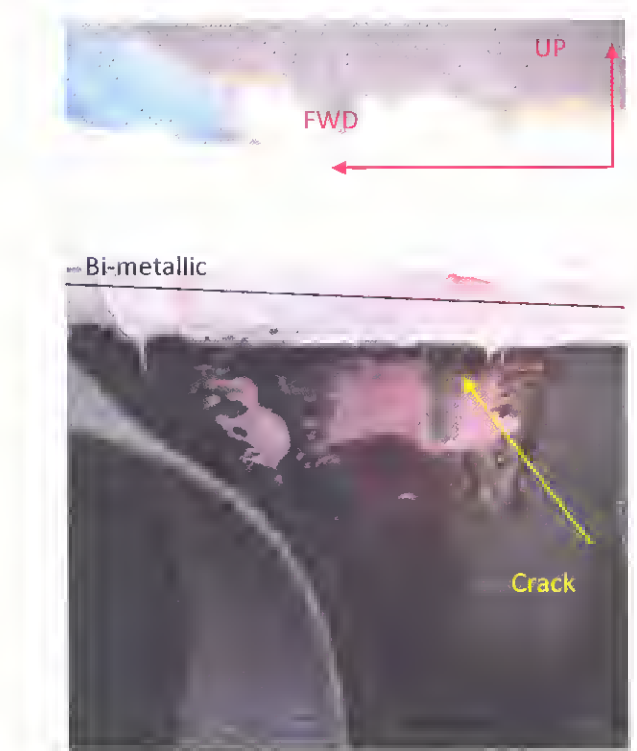
14. Crack located in steel below the bi-metallic strip. It is a vertical crack extending away from the bi-metallic strip. The crack can only be seen from the outside and with a mirror while leaning over the fashion plate. The location has been inspected each day from the inside to watch for growth through the thickness of the metal. No growth has been found.

Figure 17: Frame 57, Main Deck, Port, Outboard view of shell plating

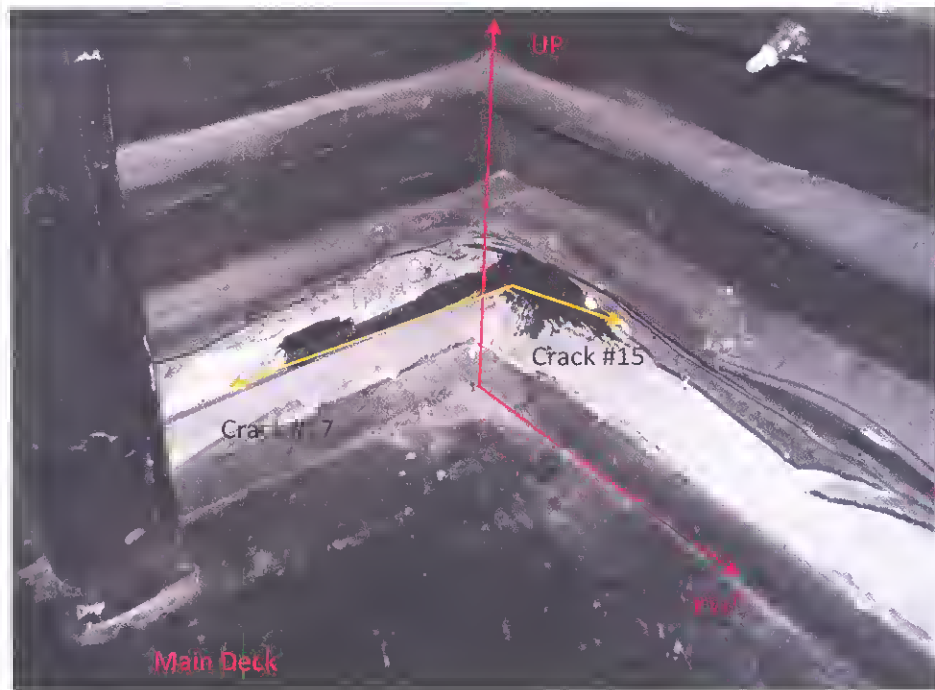
15. Crack #15 travels from the aft port corner of the deck house forward along the upper weld of the bi-metallic strip. This crack was thought to have been mitigated with a 0.625" hole drilled through the crack tip. From the mitigation hole a growth of 1.25" was found over the course of the inspections contributed to the overall length from corner to tip of 8.5".

Figure 18: Frame 57, Main Deck, Port, Interior view of port aft deckhouse corner

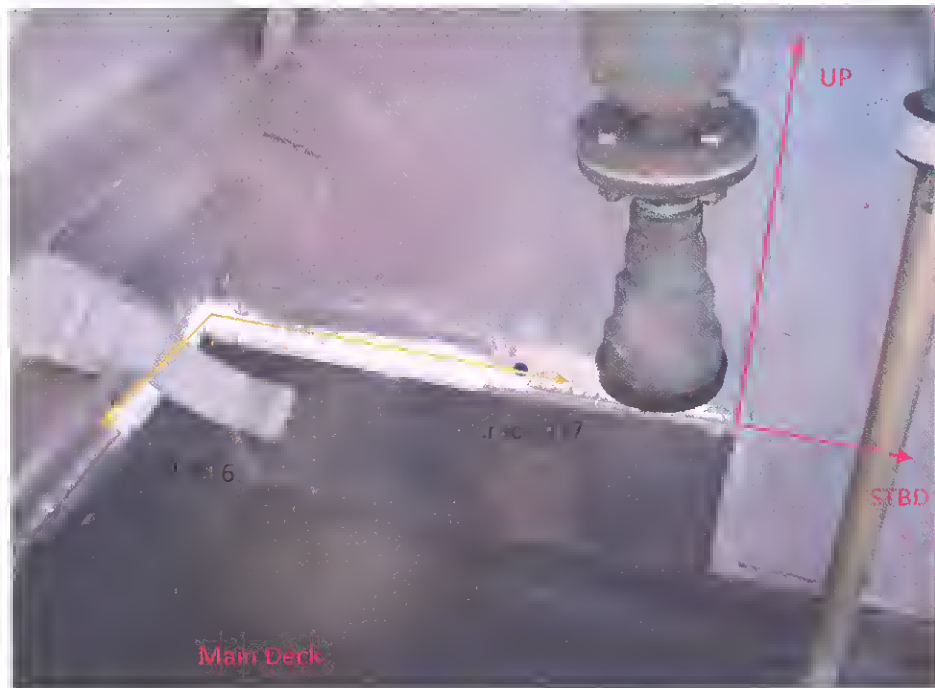
16. This crack starts in the same corner as crack #15. Like with crack #15 a 0.625" hole was drill in an attempt to mitigate the crack. Crack #16 travels aft along the upper weld of the bi-metallic strip through the fashion plate. The growth of 0.375" from the mitigation hole contributes to the overall length of 8.5".

Figure 19: Frame 57, Main Deck, Port, Exterior view of port aft deckhouse corner

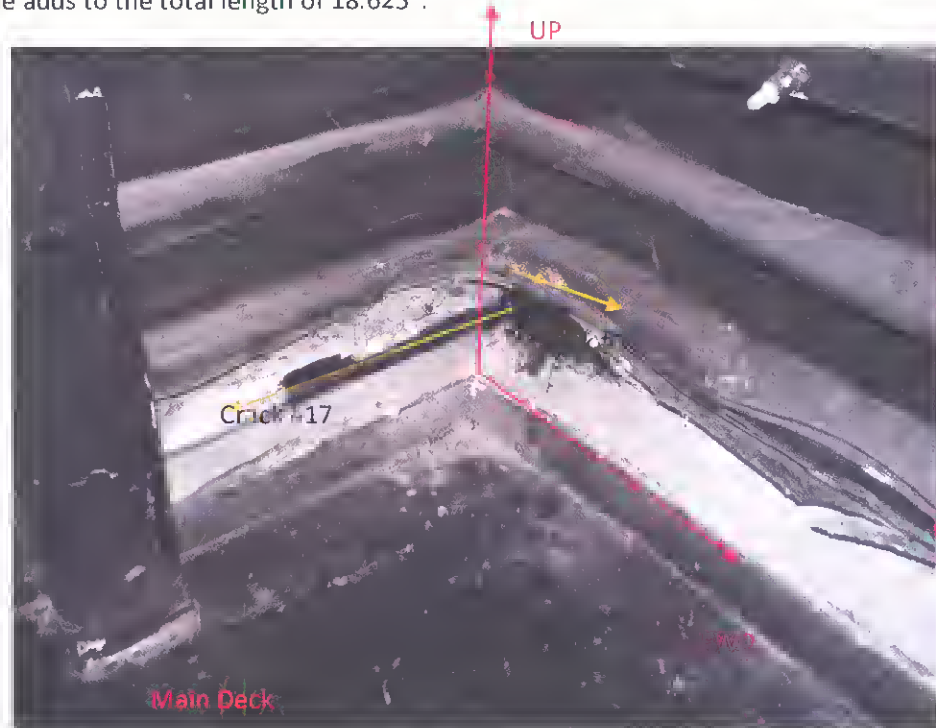
17. Again this crack starts in the same corner as crack #15. Again a 0.625" hole was used in an attempt to mitigate the crack. The crack travels along the upper weld of the bi-metallic strip along the aft face of the deck house starting from the mitigation hole. Growth of 2.75" from the hole adds to the total length of 18.625".

Figure 20: Frame 57, Main Deck, Port, Interior view of port aft deckhouse corner
